TECHNICAL REPORTS FOR 1999

APPLIED GEOLOGY PROGRAM

Report of Investigation 244
UTAH GEOLOGICAL SURVEY
a division of
Utah Department of Natural Resources

February 2000

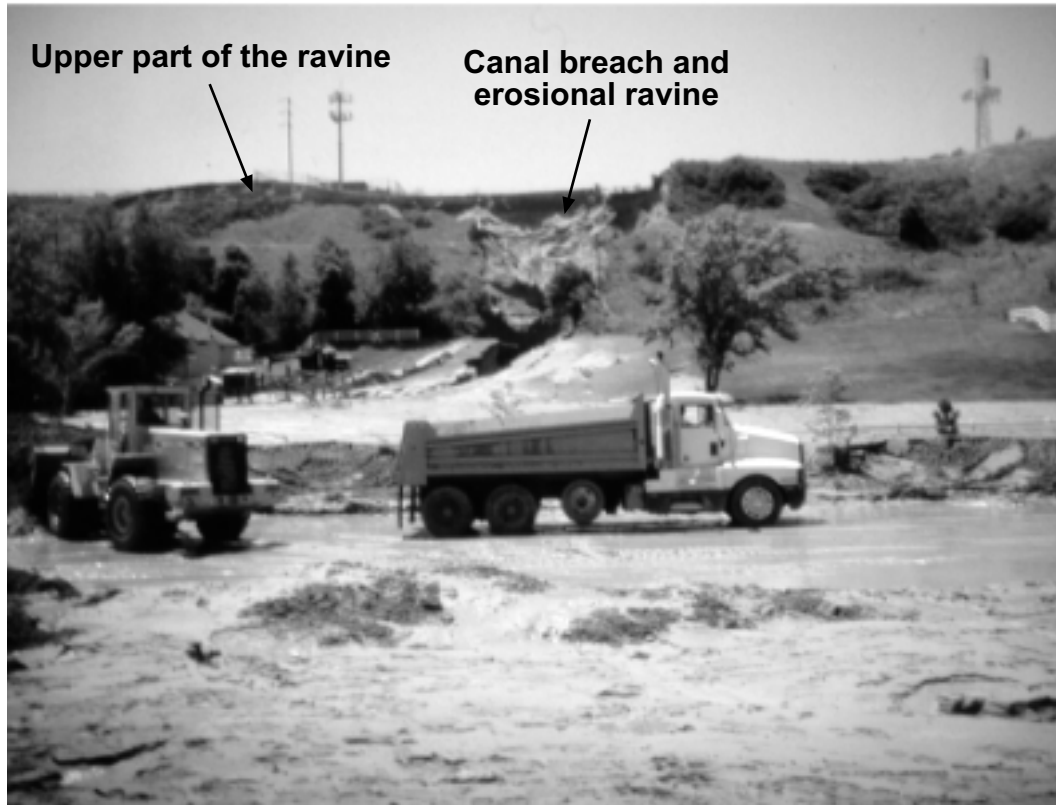
At the breach, water from the canal initially flowed downslope, eroded an outlet channel down the hillside, and began flooding the area at the base of the hill. Once the outlet was cut, continued flow as the canal drained caused headward erosion upstream, undercutting the canal and

Attachment 2. West view of the July 11, 1999, Davis-Weber Canal breach. An erosional ravine 390 feet long, 60 feet wide, and 40 feet deep is in the background. Headward erosion (to the south) during the flood produced the upper part of the ravine.

Riverdale city officials and the Utah National Guard are considering immediate measures to repair slopes in and around the erosional ravine to improve slope stability and remove hanging debris. Any such measures must be designed and monitored by qualified geotechnical engineers. We recommend the canal company also consider measures to prevent water (such as seasonal spring flow or runoff collected along the canal length) from spilling from the canal breach. We further recommend maintaining free-flowing drainage through the area so that no water ponds on the slope, and regularly inspecting re-graded slopes for evidence of movement and seepage, particularly in wet seasons and after periods of increased precipitation.

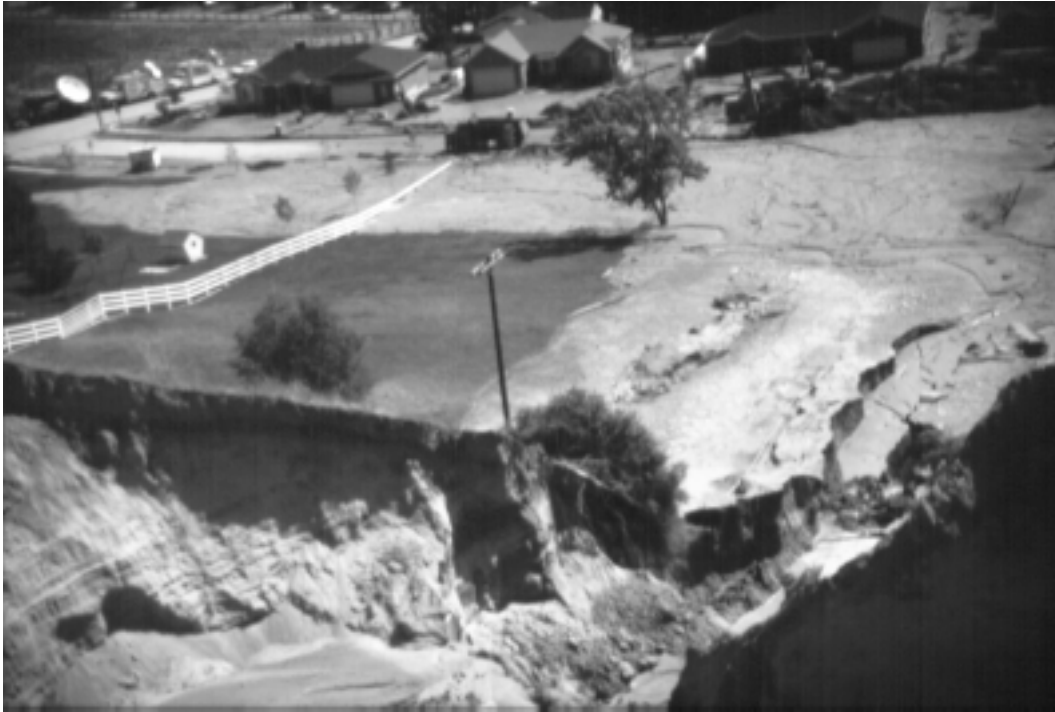
Attachment 3. East view of the outlet and sediment deposited in the Pinebrook subdivision from the July 11, 1999, Davis-Weber Canal breach.
